THIRD PROGRESS REPORT
PROJECT: CASERIO NUEVO EDEN, SANTA
CRUZ BARILLAS, HUEHUETENANGO.

COVERING THE PERIOD
(2020)

BY:
ASOCIACIÓN PRO AGUA DEL PUEBLO
February, 2021

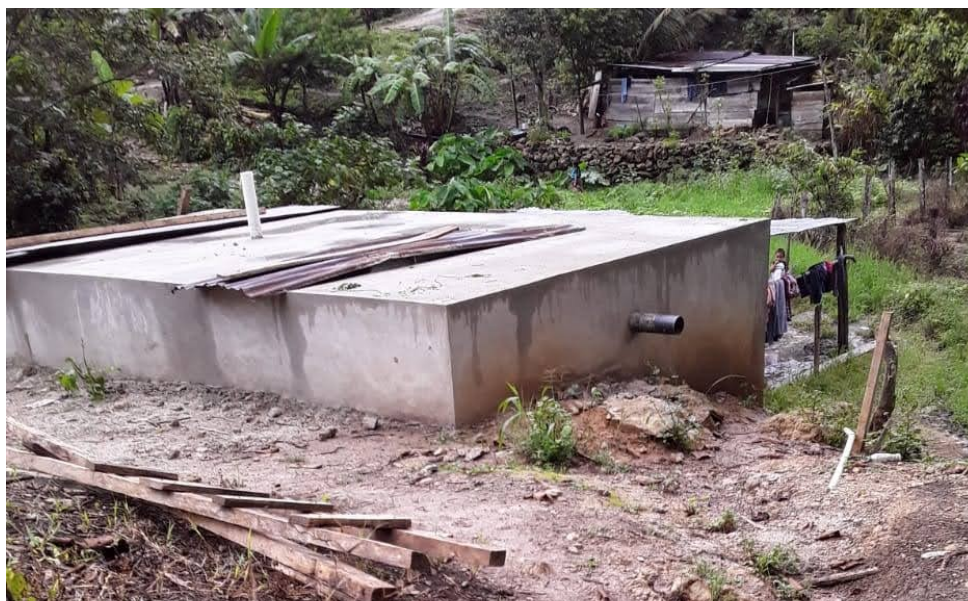
Wastewater treatment system

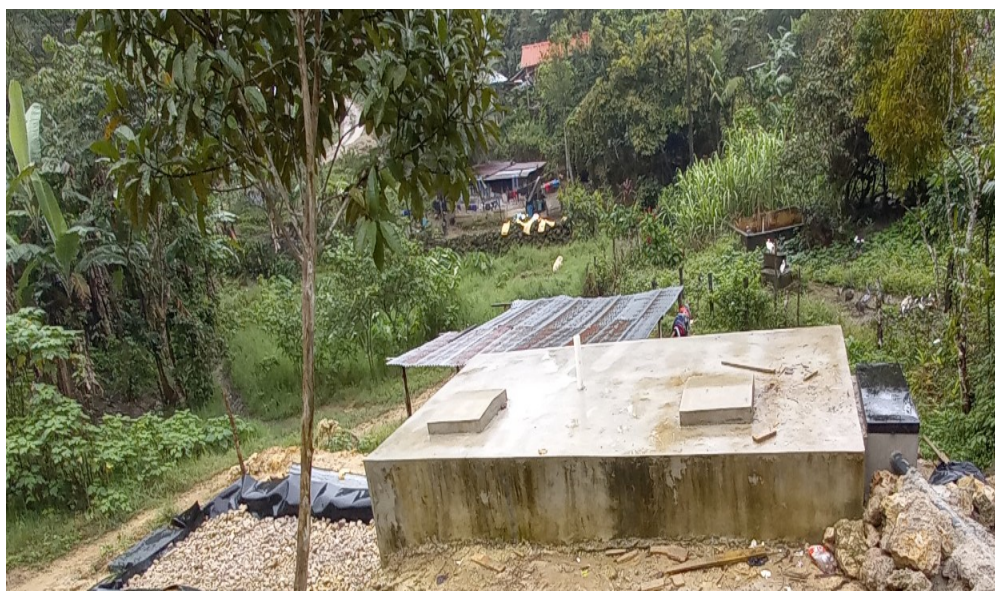
Sistema de tratamiento de aguas residuales para 29 familias. Se observa de derecha a izquierda, canal de rejillas, tanque séptico y humedal.

Wastewater treatment system for 29 families. From right to left, filter channel, septic tank, artificial wetland.

It began with the construction of a septic tank of 29 m³ of reinforced concrete with a compression strength of 210 Kg / cm² built with quality aggregates and clean of impurities, which will give primary treatment to the wastewater collected from the homes, serving to separate solids by gravity or sedimentation. Once this is done, the solids settle to the bottom of the tank, and the biodegradation process begins, which converts the polluting products into inert products. The walls are 0.15m thick

Regarding the secondary treatment in the wastewater system, it is done via two artificial wetlands, secondary treatment structures of a BIOLOGICAL TYPE that promote the growth of organisms that eliminate bacteria and non-biodegradable toxins, through filtration through strata of *boluda* stone [river rock?, pea gravel?], gravel and the roots of vegetation.

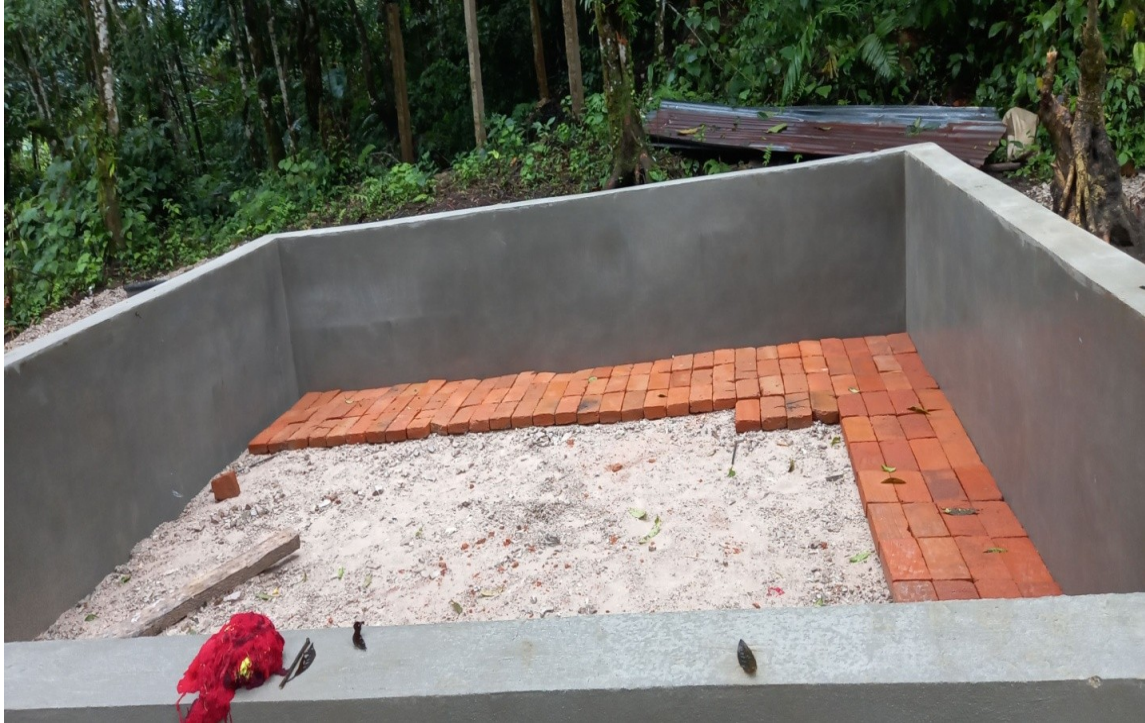
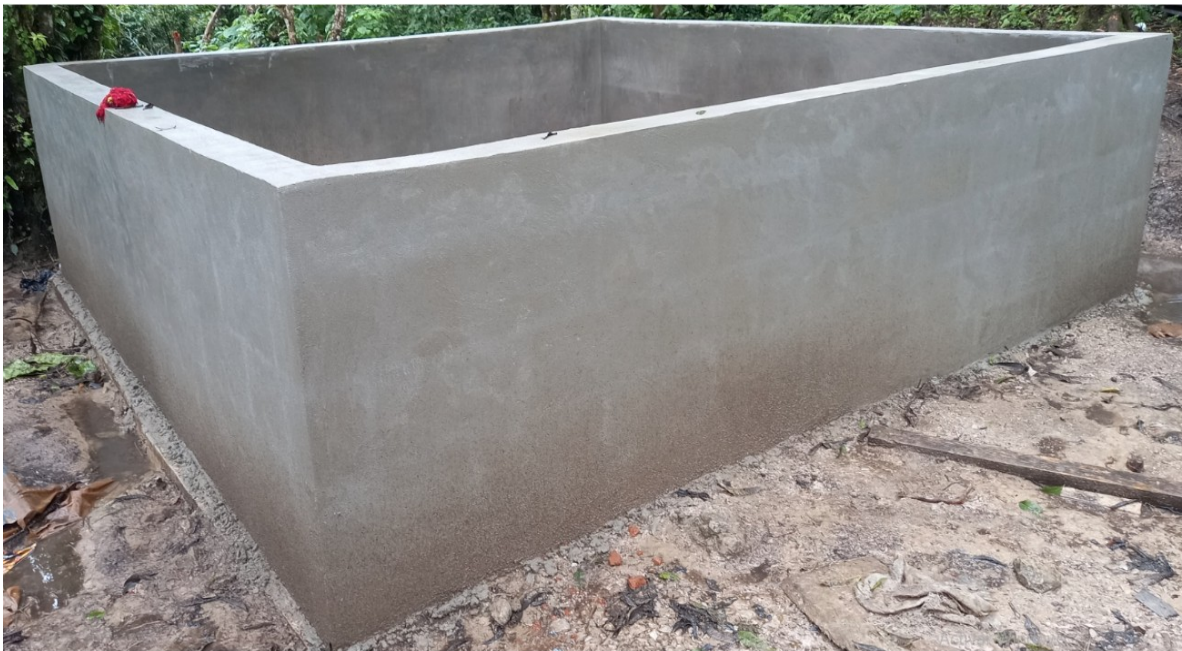
Solid waste drying patio

The construction of drying platforms - masonry structures that have the function of drying and treating the solids from the septic tanks – are to avoid dumping solids in any vacant place that might become a source of environmental contamination (see photos).

They are built of masonry block, with a gravel filtering bed and a *tayuyo* brick (a type of solid red brick) floor. The construction of two structures was contemplated, but since it was not possible to obtain the area of land where the small one would be built, an agreement was reached with the community to only build one, where the sludge of both septic tanks would be taken, and which is already finished in its entirety.

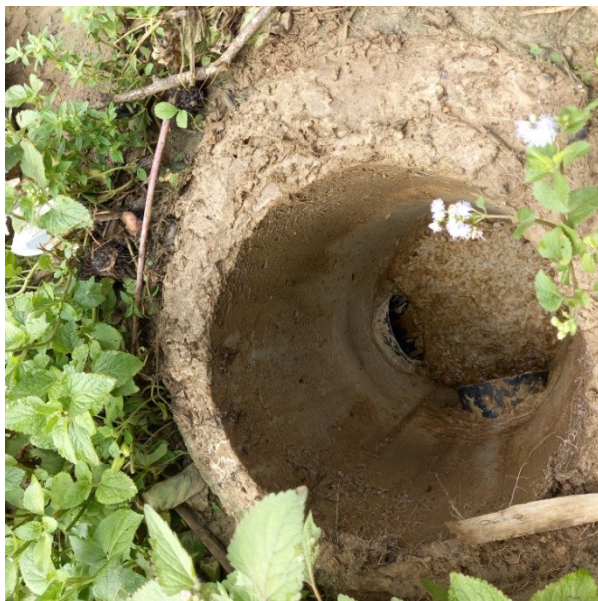
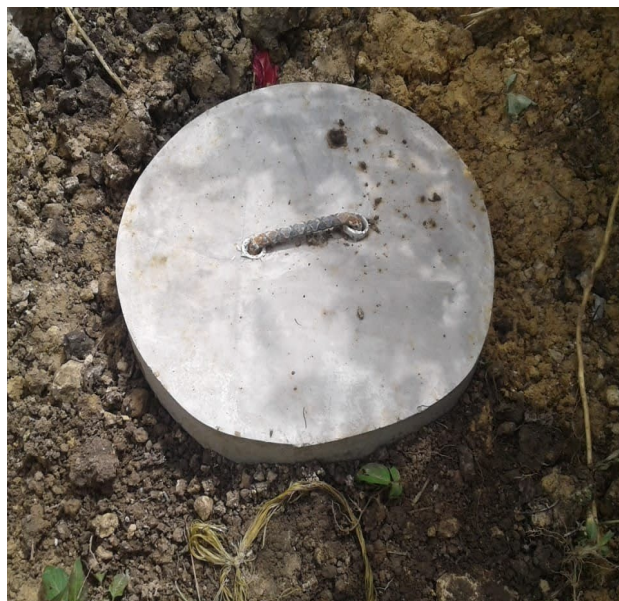
Candelas Domiciliares

Domestic cleanout manholes

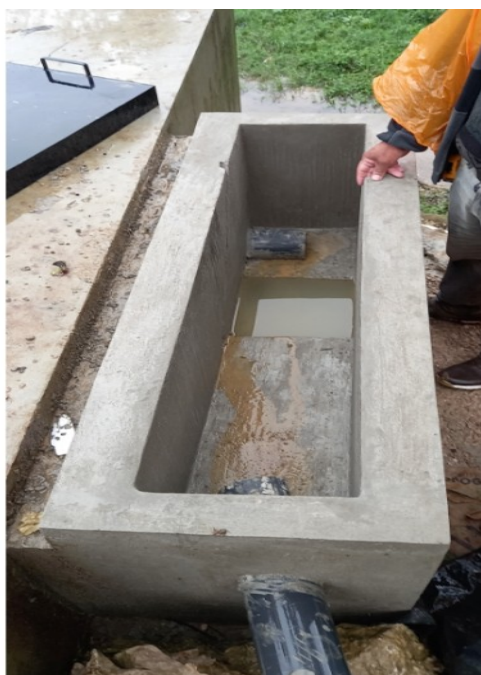
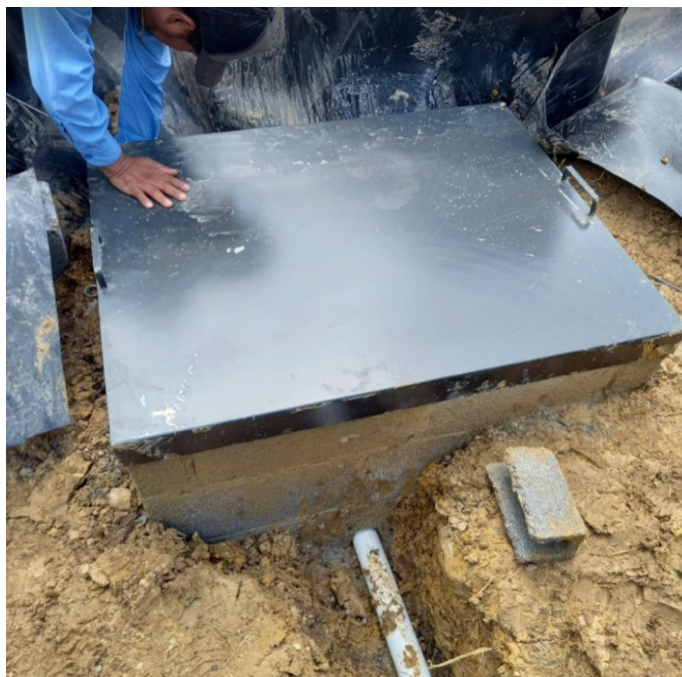
Filter channel and tank for taking samples from the artificial wetland

Sistema de tratamiento de aguas residuales que servirá para 15 familias

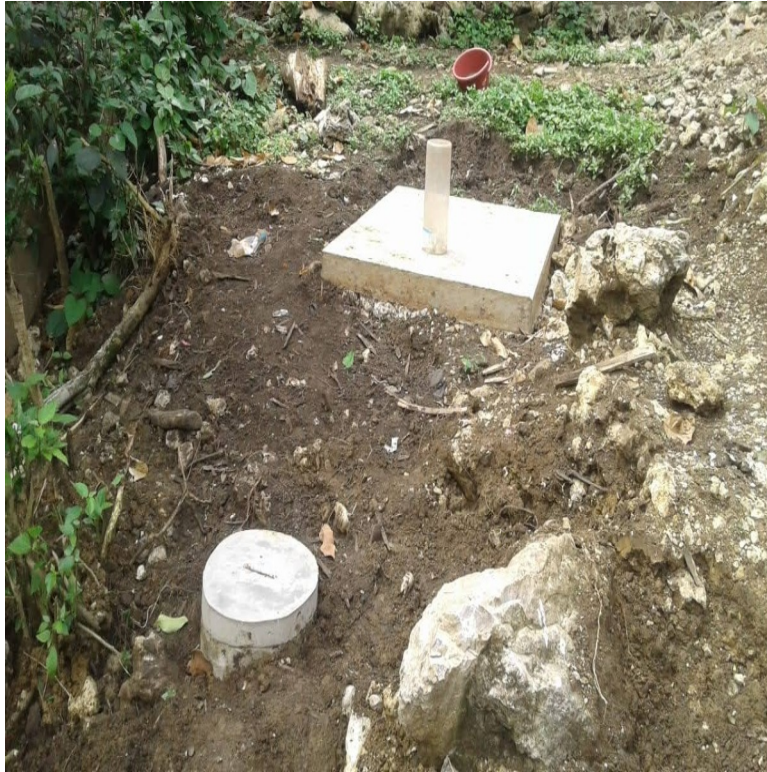
Toilet base

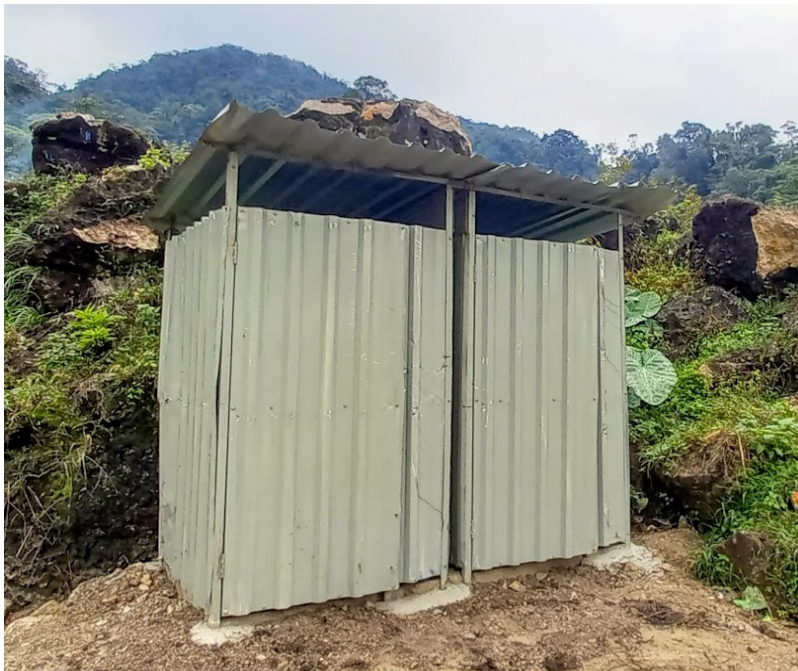
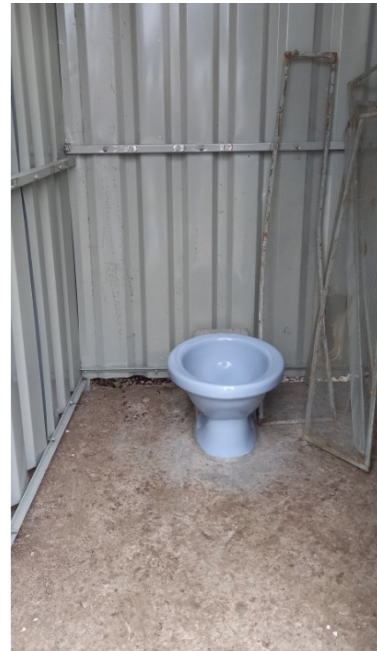
Finished latrine with washable toilet bowl

The installation of washable toilet bowls followed in order to connect them to the drainage system; due to the low water conditions in the community, manual sanitary porcelain flush toilets were proposed, with low water consumption, the purchase of said toilets was carried out in Quetzaltenango since it was the only place where they were found, so the toilets were transferred to the community. **So far, 42 toilet bowls have been installed for the same number of families, one for the community school and one for tourists visiting the lagoon.**

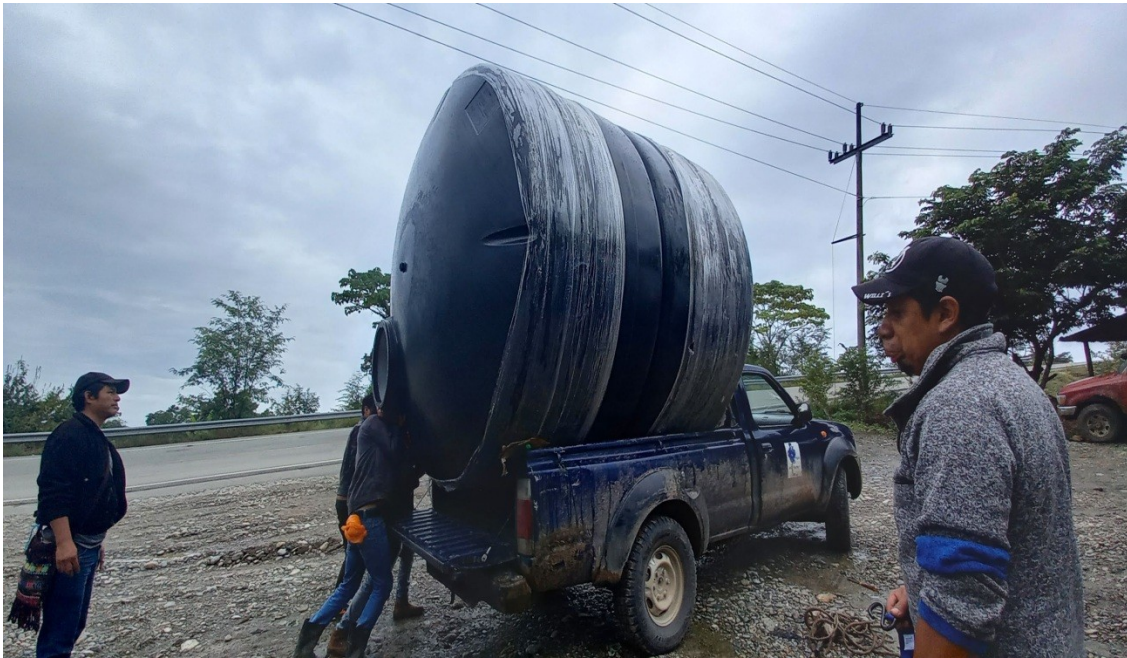
Transport of cisterns to the community: Difficulties were encountered during the transport due to hurricanes ETA and IOTA that affected the country, making it difficult for the distributor to get through; ADP had to help complete the transport to the community.

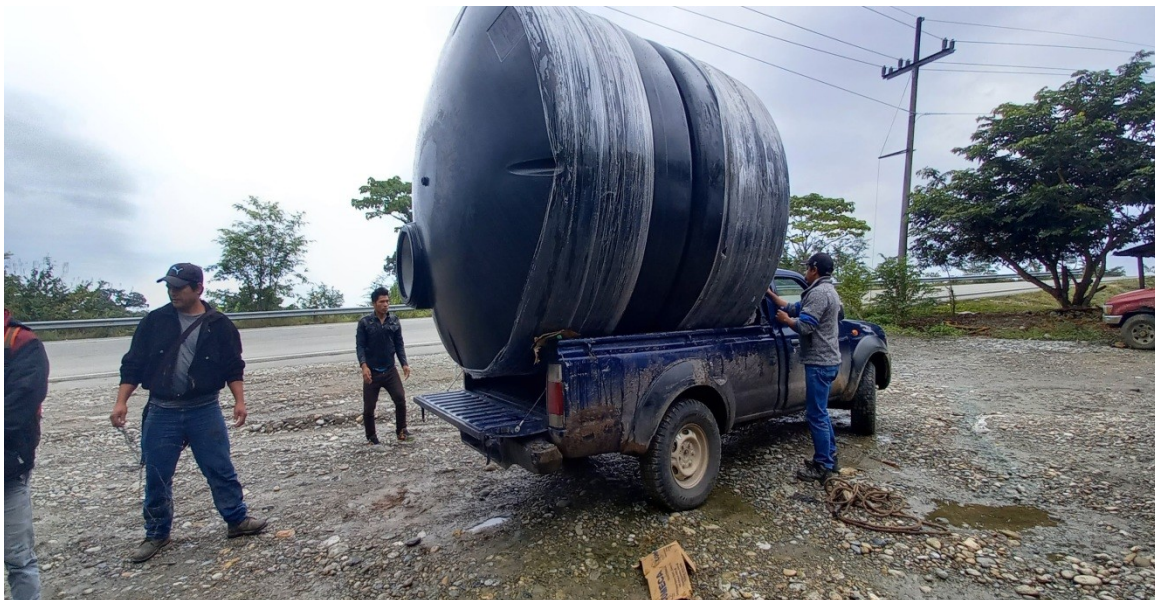
Transporting cisterns to the community

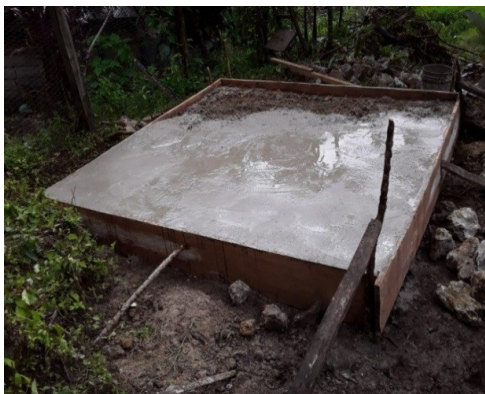
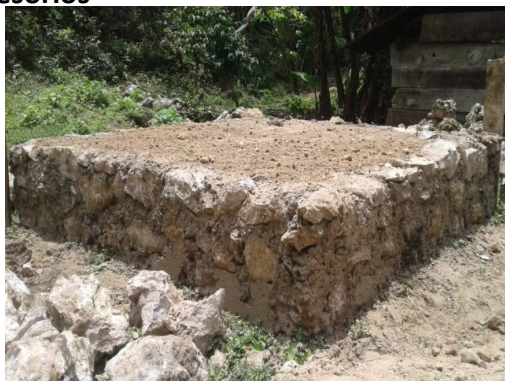
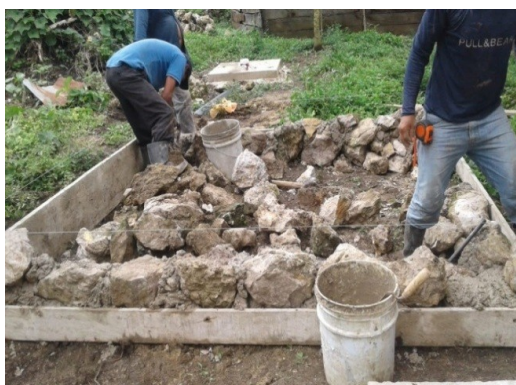
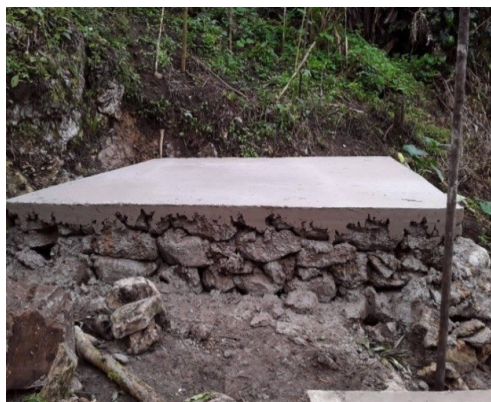
**Instalación de cisternas con base de mampostería y
accesorios**

Currently 44 cisterns are installed: 42 cisterns for the same number of beneficiaries and 1 for the school in support of school children and 1 for the tourist visiting the lagoon. Each one has its stone masonry base on which the cisterns were placed, facilitating access to water through a tap. For the protection of the cisterns and in common agreement with the community, it was established that each family would build their roof not only to capture water, but to protect them from the environment. These ceilings have their respective wooden posts and sheets, which protect the systems and extend their durability or life span. **This line is 100% completed and fully operational. See progress table and photographs in annexes.**

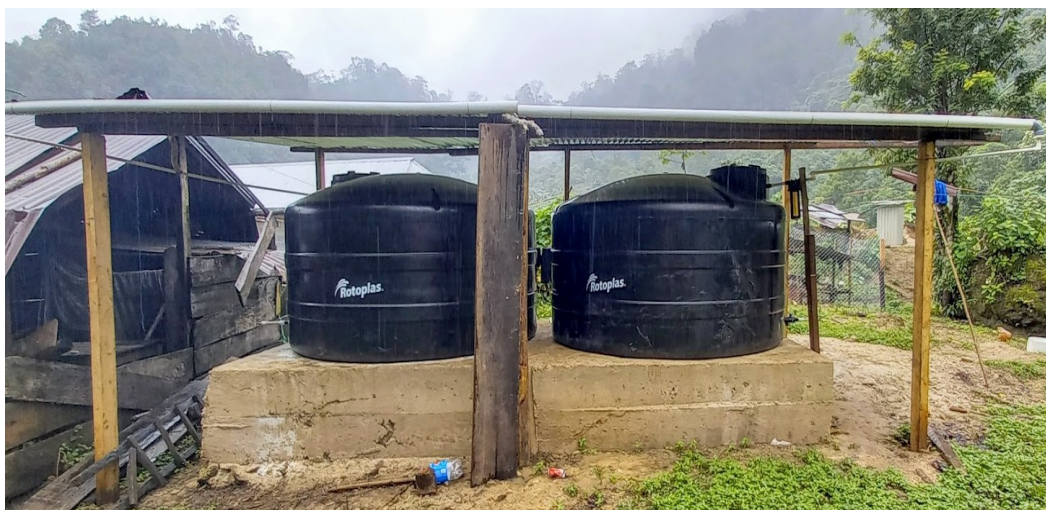
Cisterns with their roof, with wooden uprights supporting galvanized sheet metal.

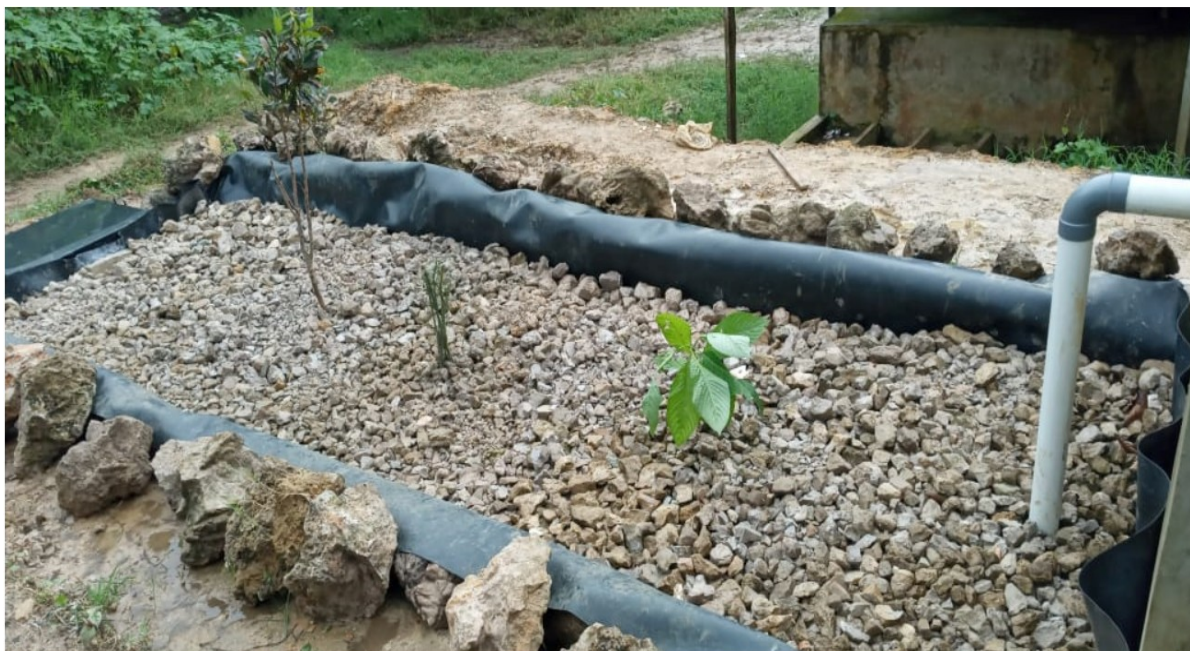
Completed artificial wetland

The structure is made up of a waterproofed tank with a one-millimeter HDPE class geomembrane; its filter bed is made up of two layers of *boluda* stone at the entrance and exit, the third layer installed in the central part will be made of ¾" gravel.

The surface part has a layer of gravel or *piedrín* [small stone or gravel] with a thickness of 5 centimeters, a bed that will serve as a substrate for the cultivation of plant species that will complement the biological treatment process. Absorption ditches are structures or channels dug in the contiguous soil of septic tanks and wetlands, to discharge treated water from wetlands.

The wetlands measure of 7.3 m³ (at the 29 m³ septic tank), and 3.8 m³ (at the 10 m³ septic tank), both are finished and two species of plants were planted to start their growth and performance. Absorption ditches are structures or channels dug in the contiguous soil of septic tanks and wetlands, to discharge treated water from wetlands.
